MONITORING OF STRUCTURES AND ELEMENTS WITH FIBER OPTICS

– VALIDATION EXPERIMENTS –

- MONITORING OF CONCRETE STRUCTURES BY MEANS OF FIBER OPTICS -

Version 1.0

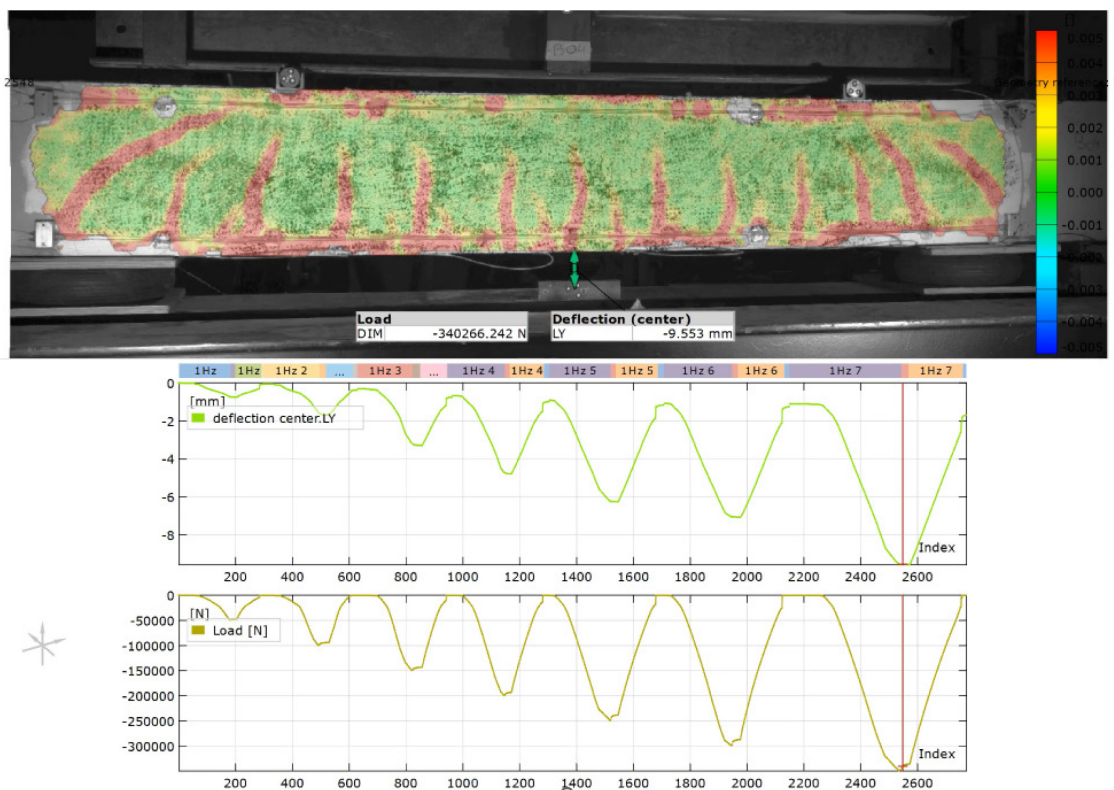
Figure 5. (Below) Load and deflection registered during the experiment in function of time. (Above) The strain profile obtained with the DIC during the last load step (at 350 kN).

One of the 4 reinforced concrete beams was subjected to a 4-point bending test in which the beam was gradually loaded to higher load levels (with a loading interval of 50 kN), this to progressively introduce damage in the beam. Upon reaching each load level, the load was held (in displacement control) and this for a few minutes in order to collect some stable (static) BOFDA measurements. The beam was then fully unloaded after each loading step to perform a dynamic measurement after which the beam was loaded again to the next load level. A preliminary analytical calculation of the cracking moment was performed. This indicated that cracks would be initiated at a loading of ± 70 kN. The first load level was therefore chosen below this loading i.e. at a load of 50 kN. In Figure 5 the force and deflection curve can be found as a function of time.

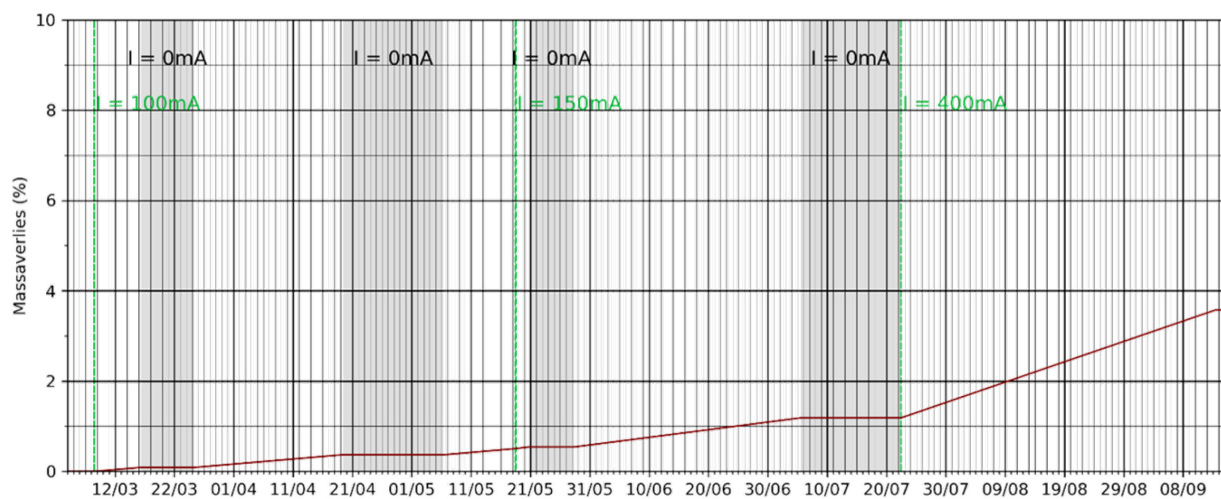
Figure 8. Predicted theoretical mass loss of the reinforcement during the corrosion experiment.

A constant current was imposed between the reinforcements and the stainless steel plate. This current was gradually increased during the accelerated corrosion test. The evolution of the predicted theoretical mass loss (calculated by means of Faraday's law) can be found in Figure 8. The real mass loss will most probably be lower than this theoretical prediction due to for instance decreasing salt concentration, etc.

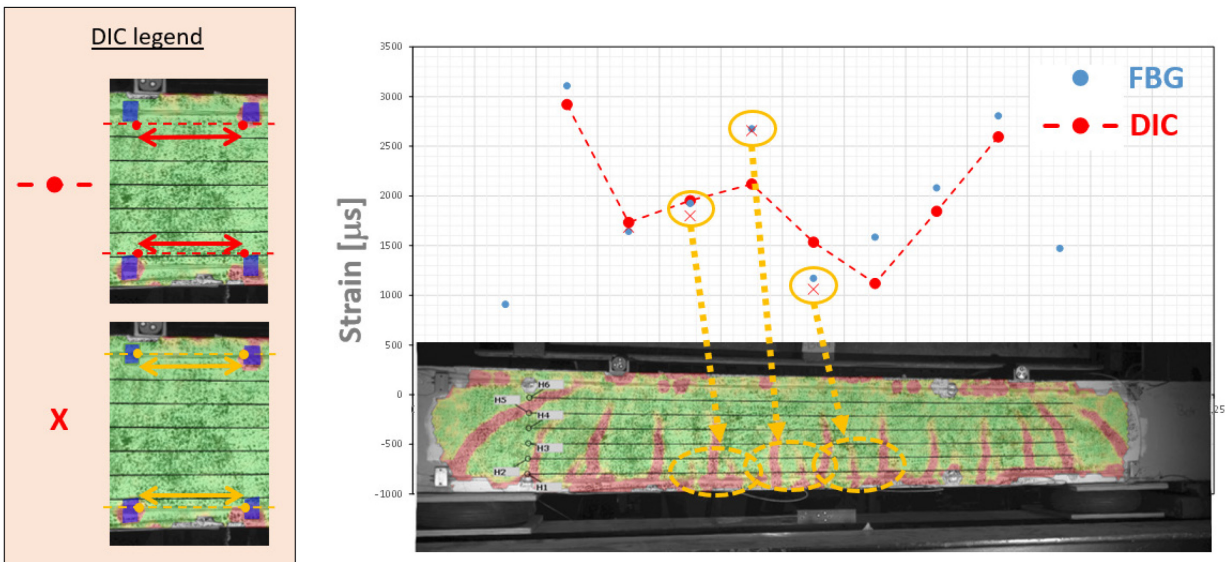
Figure 12. Results of FBGs mounted on the surface with extensometer length of 220 mm compared with equivalent DIC measurements at loading step 350 kN. (left) location of DIC measurements (right) location of smaller cracks at the bottom of the beam.

In Figure 13, the results obtained with the FBGs mounted at the front of the beam (with centre-to-centre distance of the mounting blocks of 250 mm (spacing 220 mm)) are presented and compared with the DIC measurements at the different load steps. Due to the presence of the optical fibre lines on the surface, the DIC measurement is distorted in this area. The comparison was thus carried out based on the DIC measurements just below or just above the considered optical fibre measurement line (as illustrated in Figure 12 (top left)), which may lead to a slight deviation in absolute value between both measurements, nonetheless the general evolution can be evaluated and compared. For the DIC measurements, points were fixed to the surface at the ends of the mounting blocks (cf. free length of the optical fibre between the mounting blocks). At each load step, the distance change between these points was determined.

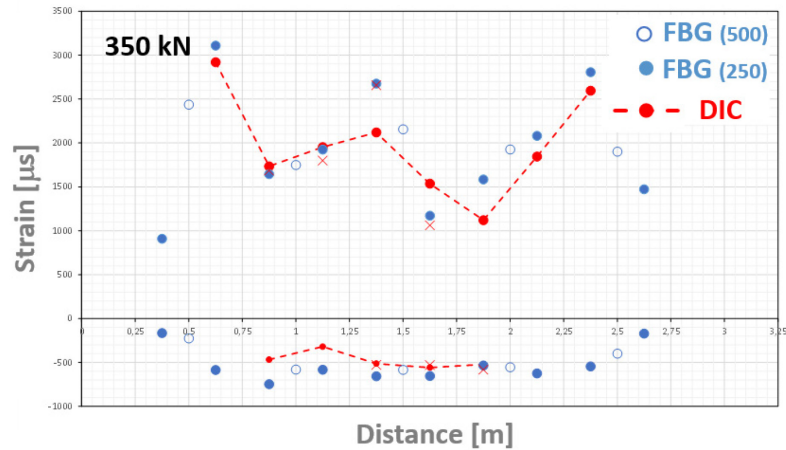
Figure 15. Results of FBGs mounted on the surface with extensometer length of 250 and 500 mm compared with equivalent DIC measurements (load step = 350 kN).

When the results of the FBGs with a measurement bases of 250 and 500 mm are put side by side (see Figure 15), a very good agreement between the two sets of measurements can be observed. The results of the FBGs with a measurement base of 500 mm lie exactly between the 2 neighbouring FBGs with a measurement base of 250 mm.

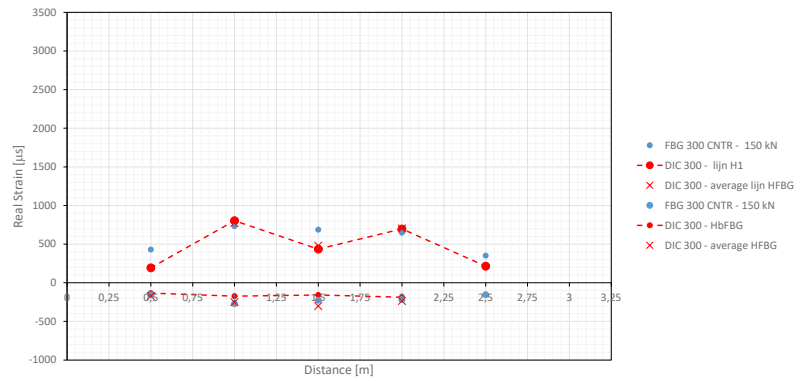
Figure 16. Results of FBGs installed in the center of the beam with a semi-extensometer setup (extensometer length of 300 mm) compared with equivalent DIC measurements.

The results of the FBGs installed in the centre of the beam in semi-extensometer setup (with tubes of 300 mm placed around the carrier rod in which the FBG is glued) are presented and compared with the DIC measurements and this for the different load steps in Figure 16. Again, a good agreement is found with the DIC measurements.

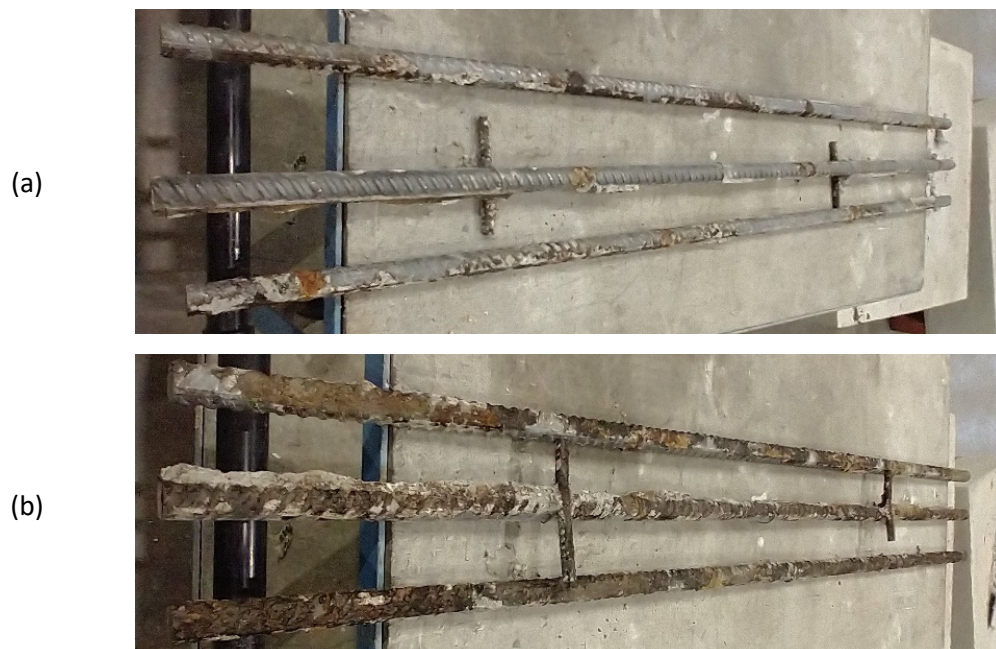
Figure 32. Pictures of the bottom rebars after the accelerated corrosion experiment: (a) top view and (b) bottom view.

When looking at the bottom rebar collected out of the beam B02 (between the two point loads) after the accelerated corrosion experiment, see Figure 32, one can clearly see that the top of the rebars are only locally corroded, probably linked to the locations of larger bending cracks. The bottom of the rebar is more uniformly corroded.

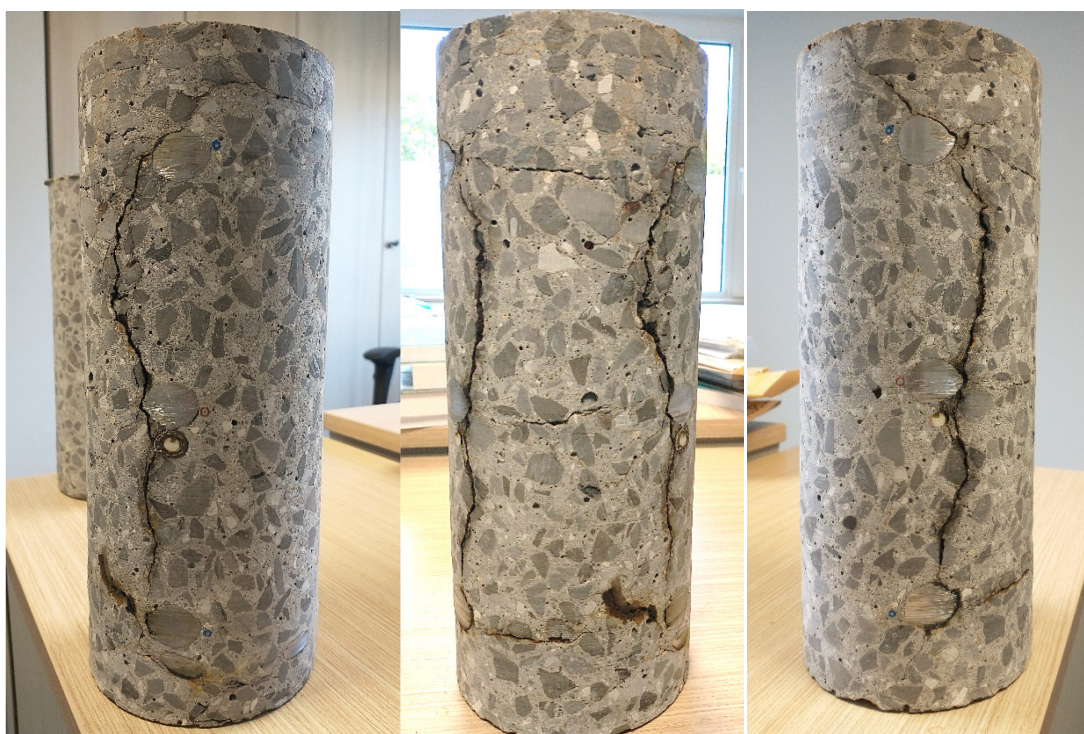
Figure 33. Pictures of a core drilling executed in beam B02 at the level of one of the point loads at the height of the lower longitudinal rebars.

At the end of the accelerated corrosion experiments, core drillings were carried out at the level of the point loads. In Figure 33 some pictures of one of these core drillings can be found, which was carried out at the level of the lower longitudinal reinforcements. It clearly shows the extensive network of splitting cracks and the deposition of corrosion products in these cracks. The optical fibre measuring lines are also visible. Based on this core, it becomes clear that the internal FBG sensors, which were provided in an extensometer setup, are located just at the level of a large splitting crack which connects the 3 rebars and moreover is characterised by a large crack width. The BOFDA measuring lines are located above the corner reinforcements and are thus less impacted by these splitting cracks. This might partly confirm the hypothesis made earlier, namely that the optical fibres are also influence by other phenomena besides mass loss.

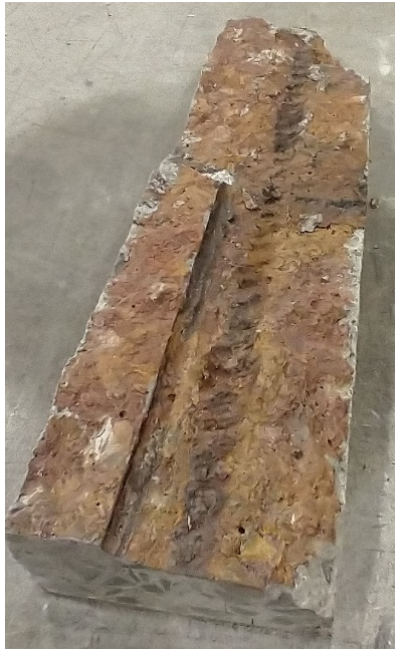
Figure 34. Picture of the crack surface of one of the splitting cracks of beam B02 after the accelerated corrosion experiment.

A photo of the crack surface of one of the splitting cracks can also be found in Figure 34. A significant deposition of corrosion products can be clearly seen in the splitting crack.
